**THE STUDY OF BUILDING COLLAPSE USING  
SAINT THOMAS'S CHURCH HALL, AKURE AS A  
CASE STUDY**

**A THESIS SUMMITTED TO THE SCHOOL OF POSTGRADUATES STUDIES  
FOR THE AWARD OF MASTER OF ENGINEERING DEGREE IN CIVIL  
ENGINEERING (STRUCTURAL ENGINEERING OPTION)**

**THE DEPARTMENT OF CIVIL ENGINEERING, SCHOOL OF  
ENGINEERING AND ENGINEERING TECHNOLOGY, FEDERAL  
UNIVERSITY OF TECHNOLOGY AKURE, NIGERIA**

**JUNE, 2005**

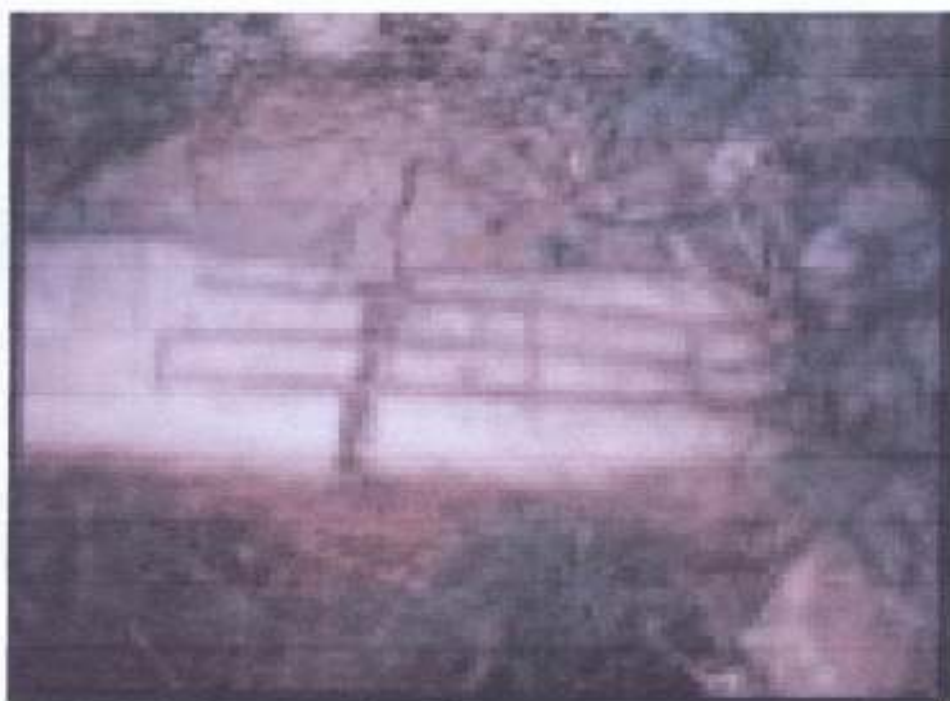
It was alleged that vibration machine was not used during the casting of all the concrete works in the collapsed building. Also, insufficient cover in the structural members would have led to corrosion of reinforcement in the concrete. All these amounted to poor workmanship as part of the principal factors that led to the collapse of the structure. (See plates 4.2 and 4.3)

**Plate 4.2: In-adequate Cover and large spacing of reinforcement**

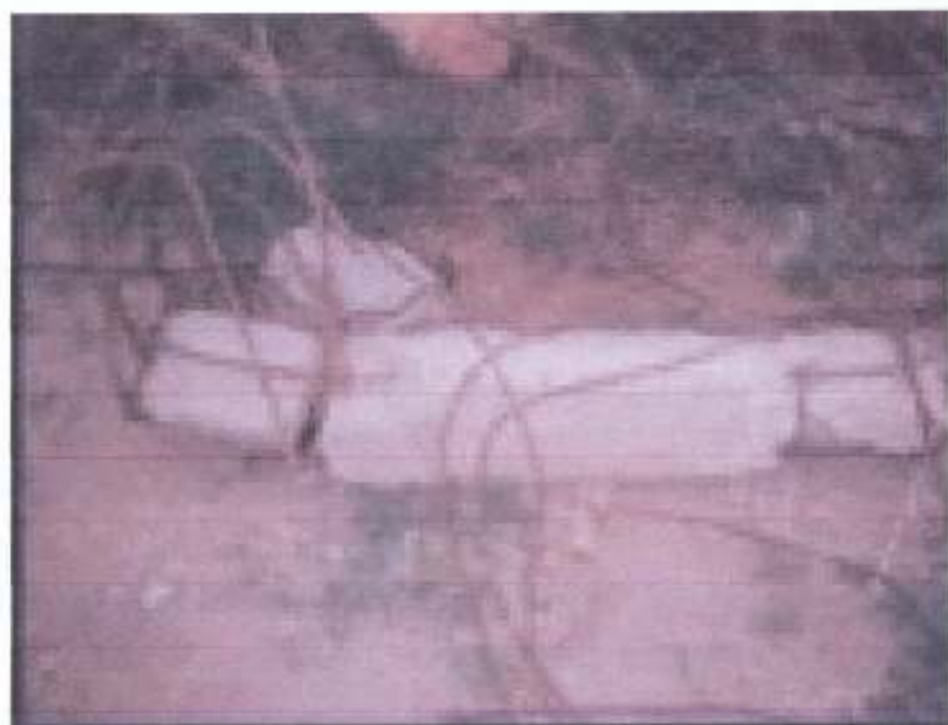
**Plate 4.3: Non monolithic Construction**
