**FAILURE ANALYSIS OF NIGERIAN  
AIR FORCE AIR BEETLE (ABT-18)  
NOSE WHEEL STRUT**

**A THESIS IN THE DEPARTMENT OF METALLURGICAL AND MATERIALS  
ENGINEERING SUBMITTED TO THE SCHOOL OF POSTGRADUATE  
STUDIES IN PARTIAL FULFILMENT OF THE REQUIREMENT FOR  
THE AWARD OF M.ENG IN METALLURGICAL AND MATERIALS  
ENGINEERING OF THE FEDERAL UNIVERSITY OF  
TECHNOLOGY, AKURE, ONDO STATE IN NIGERIA.**

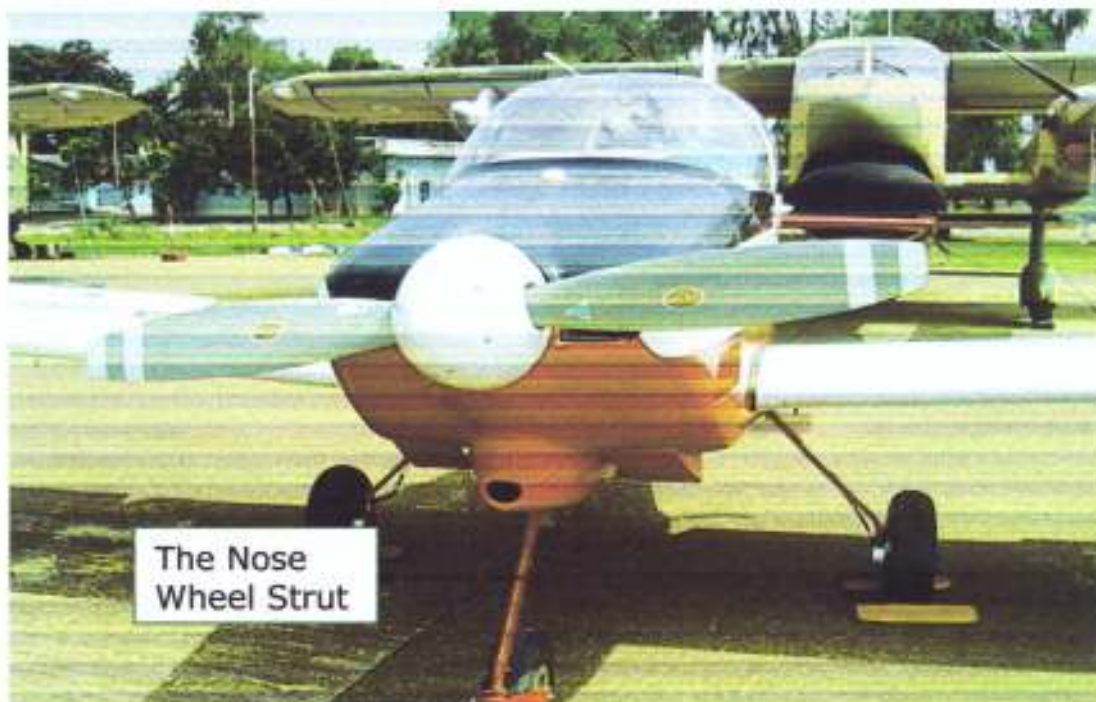
**Plate 1:** The Air Beetle (ABT-18) Aircraft

The Air Beetle aircraft is a trainer aircraft used for ab-initio training at the 301 Flying Training School of the Nigerian Air Force Base, Kaduna. Its basic design is a cantilever low wing monoplane with a single tractor engine, low mounted tail plane and elevator. The fuselage is a conventional stressed skin all-metal monocoque aluminium alloy airframe construction except for steel components comprising of the engine mount, landing gear struts, main landing gear mounts, elevator bell cranks and other miscellaneous items. Fiberglass moulds are used for the tips of wings and tail surface as well as for cowls, wheel spats and empennage fairings. It has a stainless steel firewall and engine mount (Abdullahi *et al.*, 2006). Its general characteristics are as follows:

- Crew : one pilot
- Capacity : one passenger
- Length : 6.21m
- Wingspan : 7.10m
- Height : 1.62m
- Wing area : 10.2m
- Empty weight : 437kg
- Loaded weight : 724kg
- Maximum take off weight : 724kg
- Power plant : (112-134KW) (Van's Aircraft, 2008)

On its silver anniversary April 22, 1989, the Nigerian Air Force unveiled and conducted a test flight of a prototype of Nigeria's first domestically assembled aircraft, the Air Beetle shown in Plate 1. It was jointly built over two years by the NAF and Dornier Aviation Nigeria AIEP Limited (DANA), a West German Kaduna-based firm, from the design of the United States Van RV-6 sport aircraft shown in Plate 2. The Air Beetle had the unique feature of being able to fly on standard automobile fuel. This two-seater, single airplane was intended to be the primary trainer for the NAF, replacing the aging British Bulldog trainers ([www.photius.com](http://www.photius.com), 1991).

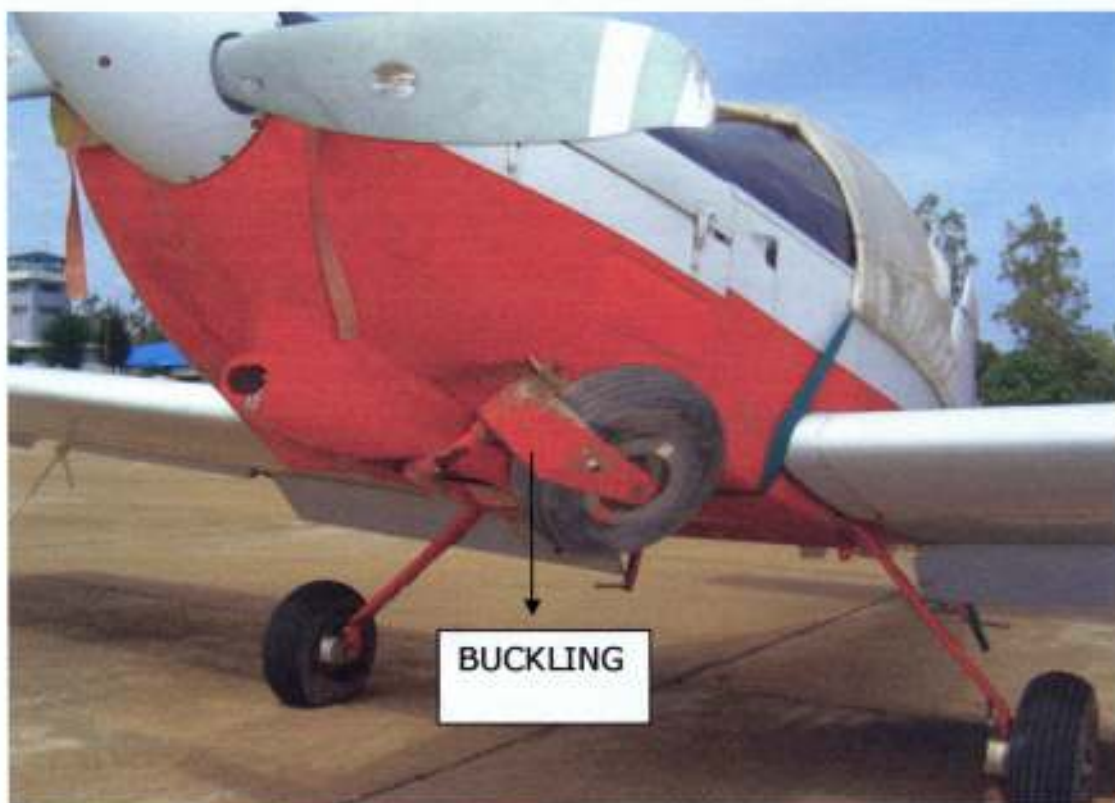
**Plate 3:** A Buckled Nose Wheel of the Air Beetle

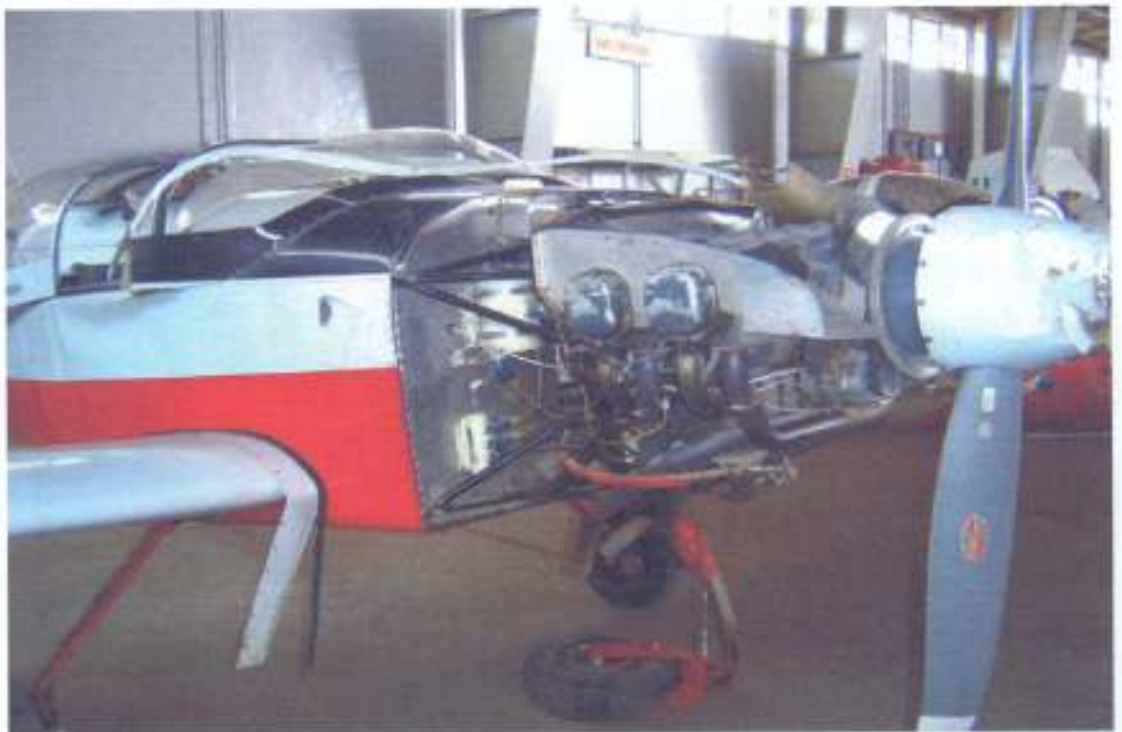
**Plate 4:** A Buckled Nose Wheel of the Air Beetle

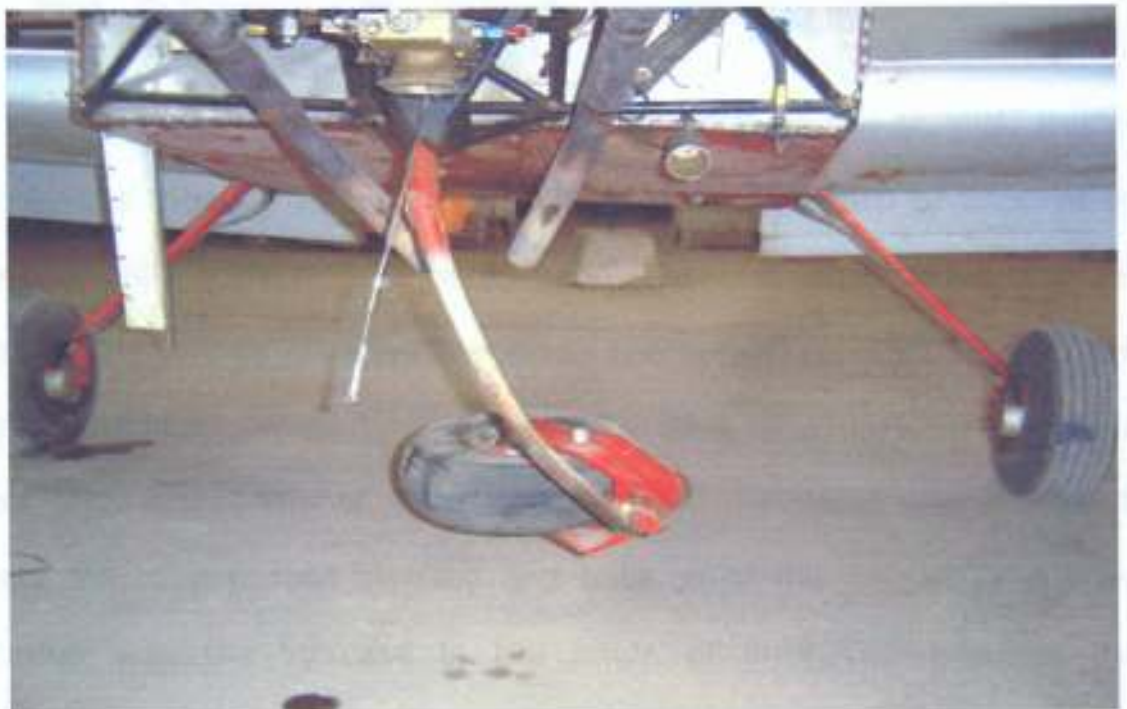
Failure occurred essentially by the student pilots. The failure modes include: buckling of the strut as shown in Plates 3-5 and complete fracture of the strut from the firewall where it was mounted as shown in Plate 6. Fracture could have occurred as a result of stress concentration on the upper part of the strut, which may have been prevented if the stress could be transmitted through the entire length of the strut.

**Plate 5:** A Buckled Nose Wheel of the Air Beetle

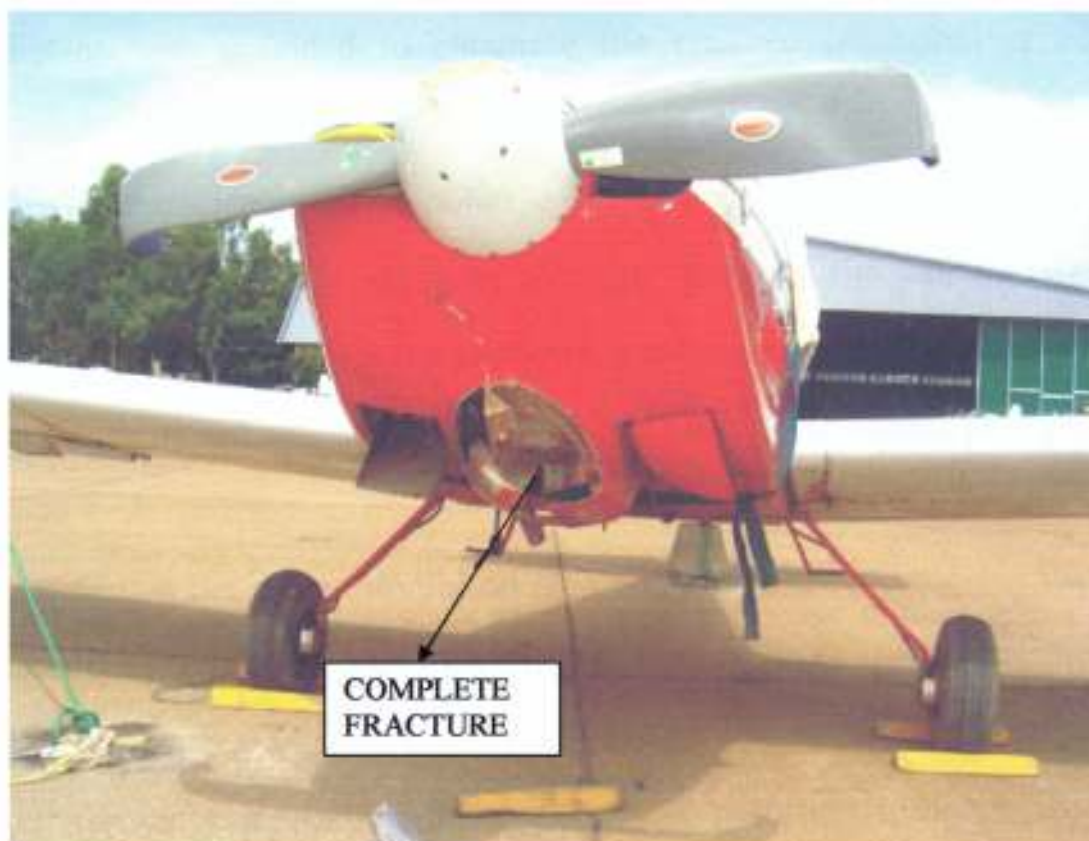
**Plate 6:** Fracture of the Air Beetle Nose Wheel

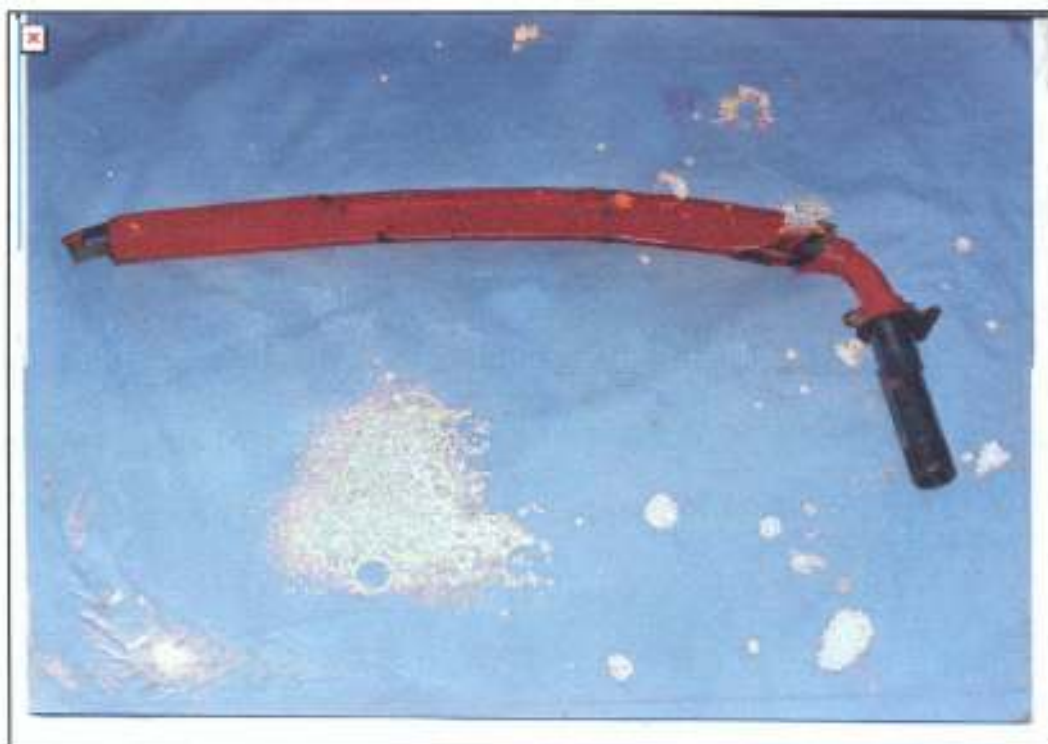
**Plate 8:** As- Received Failed Sample (F)

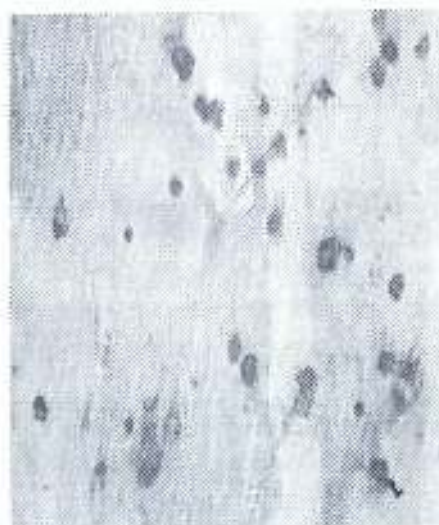
**Plate 10:** Photomicrograph of Standard Sample showing few large inclusions with pearlite (dark) in ferrite matrix (white); Longitudinal section

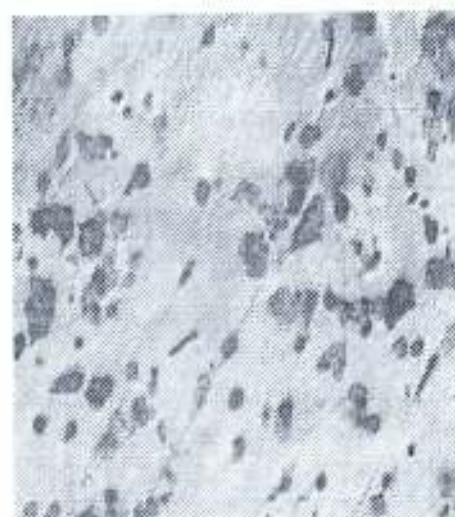
**Plate 11:** Photomicrograph of Failed Sample showing fatigue cracks propagating from dark inclusions; longitudinal section.
